Pentium® II Processor Specification Update

Release Date: August 1997

Order Number: 243337-004

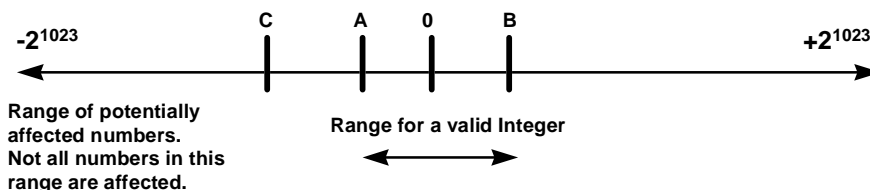
IMPLICATION: Erroneous operation results when the operand is so large that it will not fit into the target data size. The operands affected by this erratum are significantly outside (by a factor of 3X) the range that can be, correctly, converted to an integer value. The figure below and corresponding table identifies the normal range of integer numbers (between A and B) and the starting point of the operands affected by this erratum. Discrete failing operands will be present in the range between point C and the maximum negative number that can be represented by the processor (-2^{1023} in double precision format). Note 2 below gives a qualitative description of the nature of the discrete failing values. Software that does not rely on the Invalid Operation exception flag being set and signaled by either an exception OR by software polling is not impacted by this erratum.

16-bit Operation	A	B	C
	-32,768.0	+32,767.0	< -98304.0
32-bit Operation	A	B	C
	-2,147,483,648.0	+2,147,483,647.0	< -6,442,450,944.0

WORKAROUND: Any of two software workarounds will avoid occurrence of this erratum:

1. Range checking performed prior to execution of the FIST[P] instruction will prevent the overflow condition from occurring, and may already be implemented as a standard coding style.
2. Software can use the presence of MAXNEG in the result integer to indicate that an out of range conversion may have occurred.
